0115-L-18/1
30 July 2018

Test report

Terrabarrier BL 365 C3, article 0026839

determination of resistance to root penetration

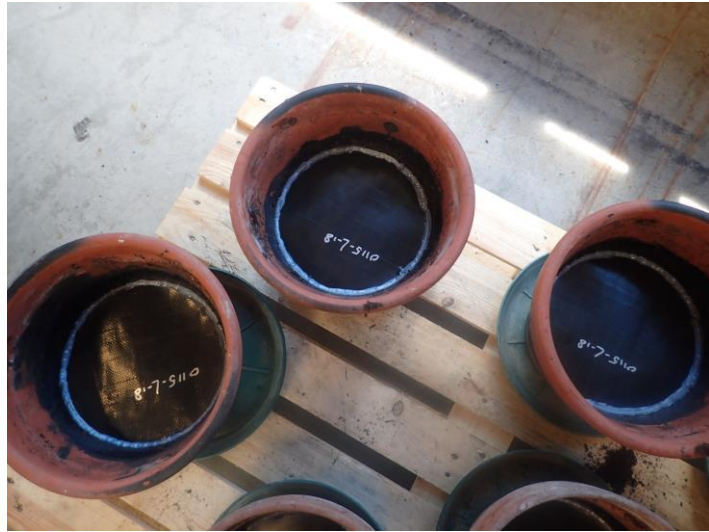
Photo 1

Three test specimens has been placed in the flower pot and has been sealed with a silicone mastic sealant.

Three test specimens and one reference specimen have been built up by Mr P. Golverdingen of Kiwa BDA Testing B.V. on 29 may 2018. See annex II for photos of the buildup of the test specimens.

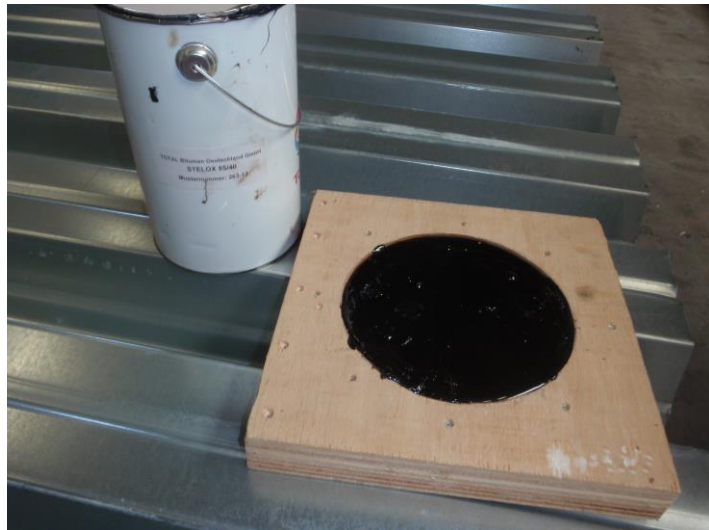
Photo 2

Bitumen 85/40 and reference test specimen.

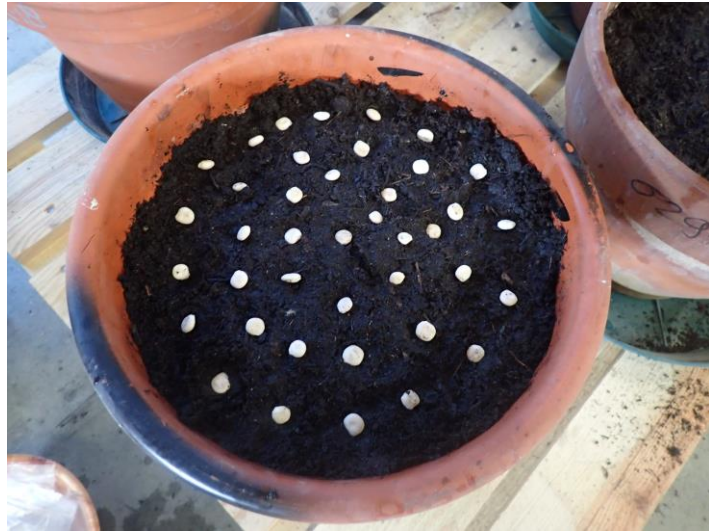
Photo 5
Plant seeds have been laid on the soil.

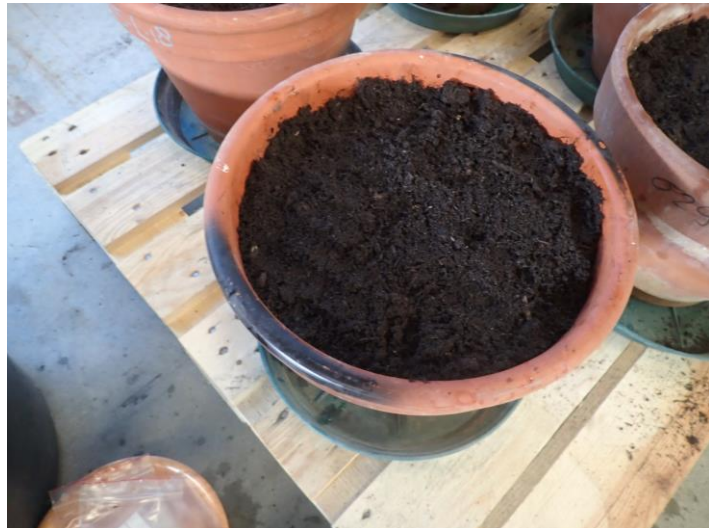
Photo 6
Seeds have been covered with soil and the tube has been positioned in the middle of the pot.

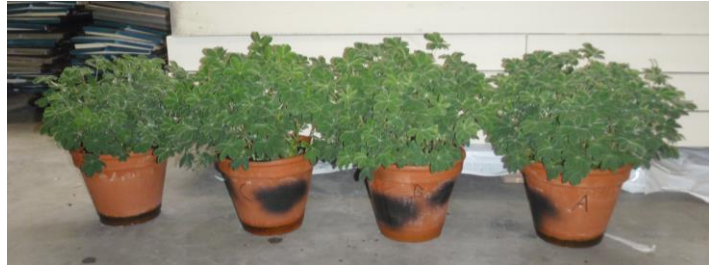
Photo 1

Plants after the growing period (six weeks).

The test duration has been determined at six weeks. After this period the seeds appeared to have been developed to healthy young plants.

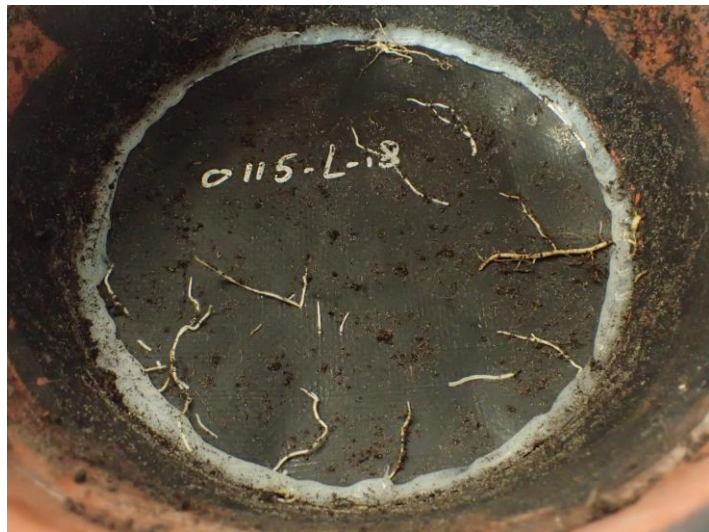
Photo 2

The upper surface of the test specimens after the growing period.

After the growing period of six weeks no penetration into or through the test specimens is observed. The reference with the 20 mm thick layer of bitumen 85/40 showed root penetration.

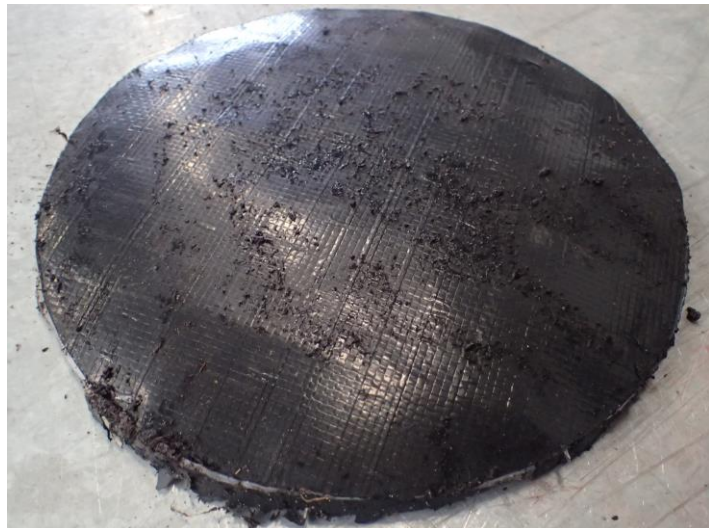
Photo 3

The lower surface of the test specimens after the growing period.

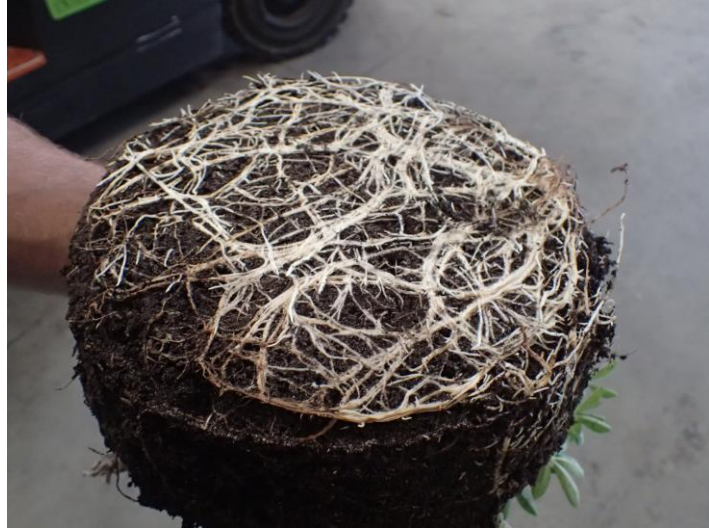
Photo 4
Root penetration through
the bitumen layer of the
reference specimen.
